Townsend Lakes Aquatic Plant Management Plan Update

Wisconsin Lake & Pond Resource LLC

November 9, 2024

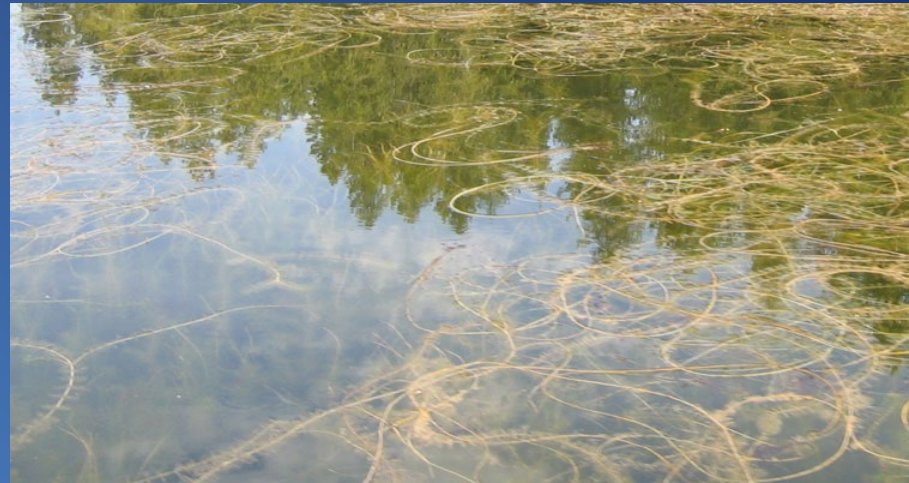
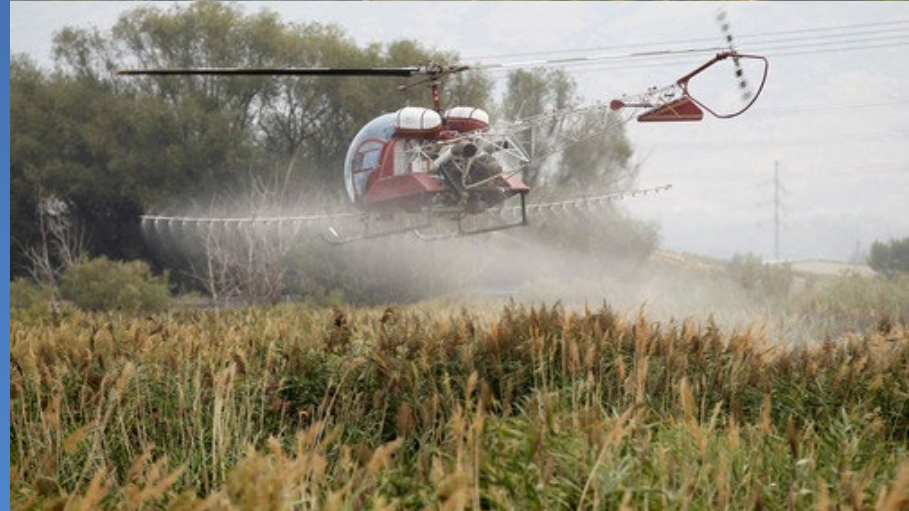
Eurasian water-milfoil

- Introduced in the 1960s
- First found in 2005 in the Townsend Lakes
 - Reservoir Pond & Horn Lake
- Most common AIS found in WI waters
 - 957 lakes or rivers
 - 38 waterbodies in Oconto Co.
- Problems caused by EWM
 - Very fast & dense growing
 - Can hamper navigation
 - Spreads easily by fragmentation
 - Monotypic stands
 - Hybridize with native milfoils
 - Potentially even more difficult to control

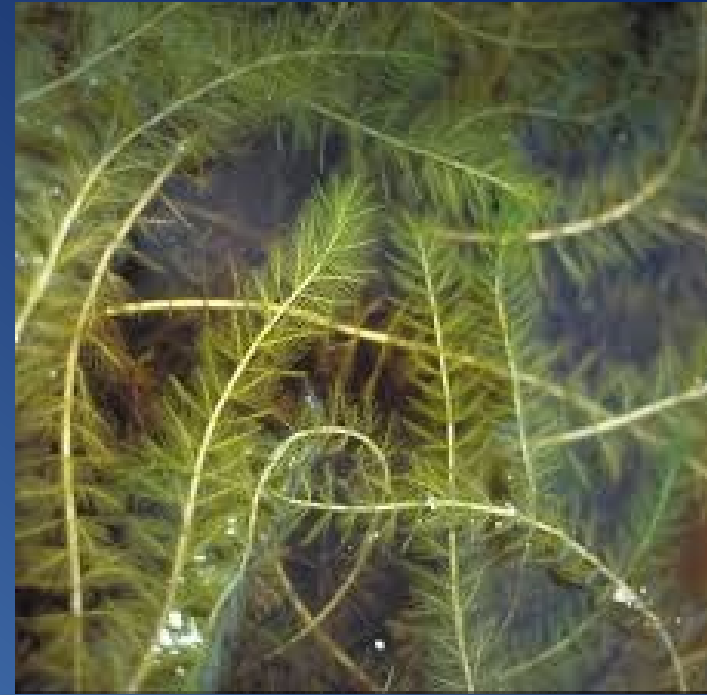
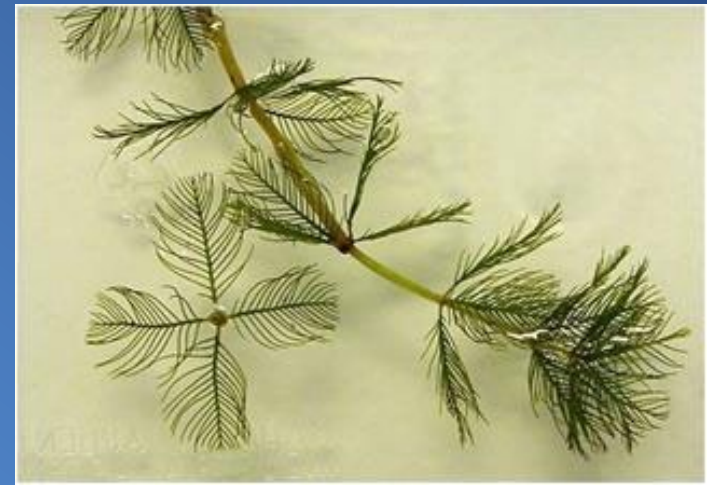
Curly-leaf Pondweed

- Introduced in the 1960s
- Commonly found in WI waters
 - 927 lakes or rivers
 - 8 waterbodies in Oconto Co.
- Found during the 2024 plant surveys
 - Likely present well before then
- Problems caused by CLP
 - Very fast & dense growing
 - Can hamper navigation
 - Monotypic stands
 - Requires multi-year control
 - Turions, seed-like structures, buildup in lake sediments

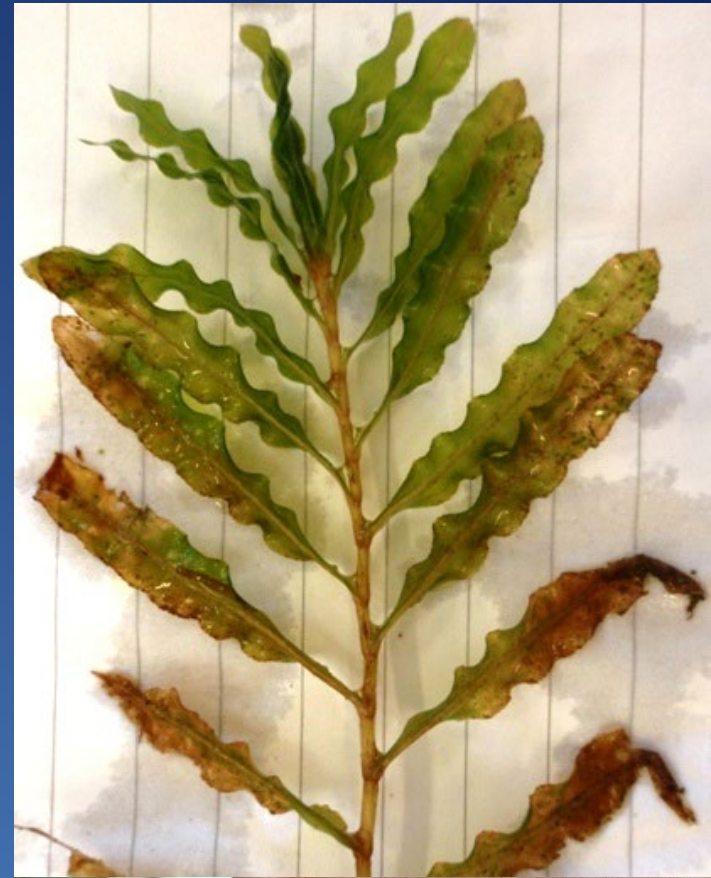
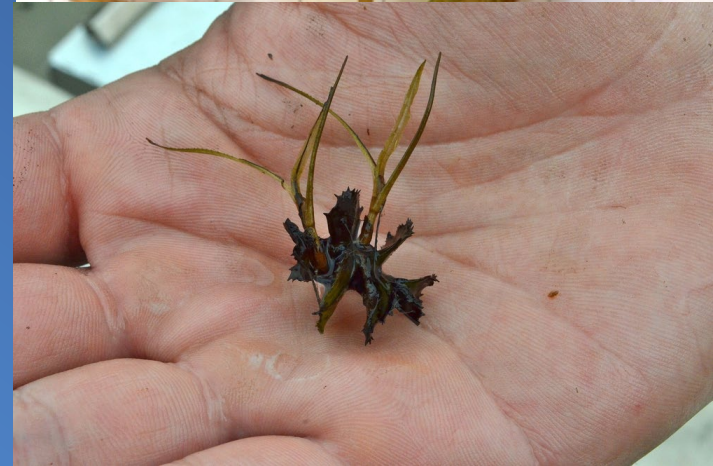
- Newly introduced into WI
 - First found in 2014
 - 31 inland lakes
 - Lake Michigan – Door County and Green Bay
- Not yet confirmed in Oconto County
- Problems caused by Starry Stonewort
 - Can be waterbody dependent
 - Very fast & dense growing
 - Can hamper navigation
 - Monotypic stands
 - Control extremely difficult
 - macroalgae

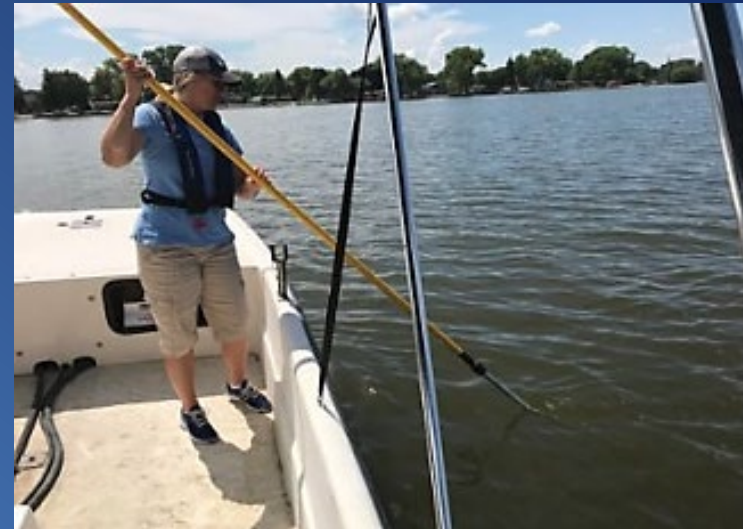
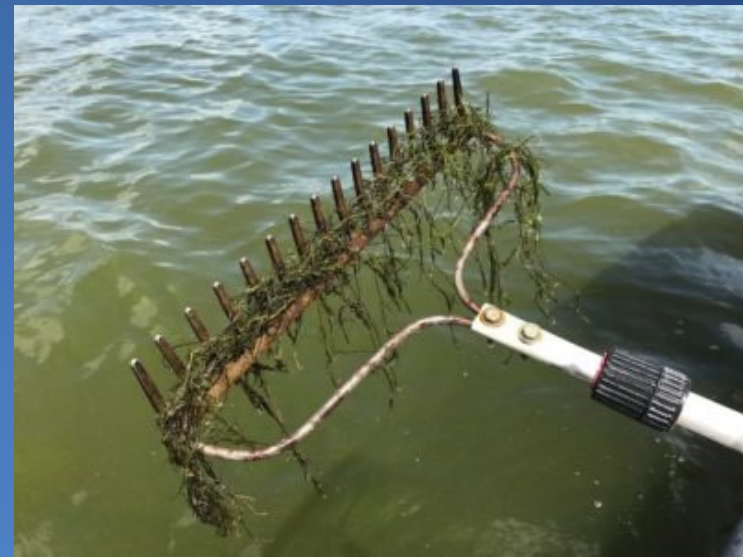
How – Aquatic Plant Survey

- A healthy aquatic plant community supports a healthy lake
- Point intercept method
 - 1855 pre-determined sample locations
 - Spaced 100-215 ft apart
 - Spacing depends on lake size, layout, depth
- At each location record:
 - Depth
 - Bottom type (sand/muck/rock)
 - Plant species present
 - Density
 - Each species
 - Overall

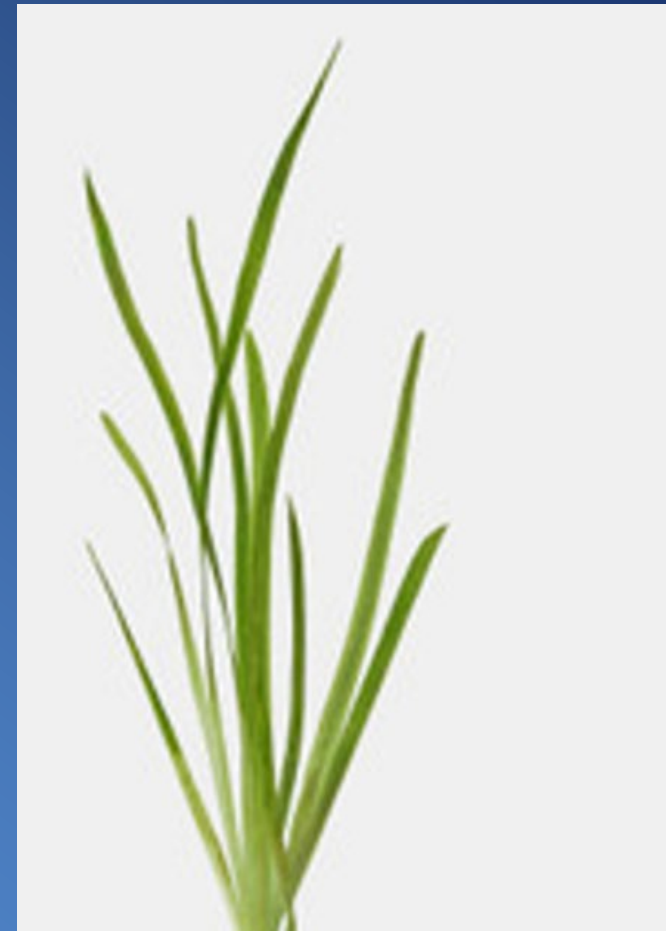
- Up to 31 different species recorded
 - All lakes had at least 19 different species
- Vegetation throughout much of the lakes and locally very dense
 - Maximum depth of 20ft (Little Horn)
 - In most of the lakes the photic zone is heavily vegetated
 - Most common species found:
 1. Eurasian water-milfoil
 2. Fern pondweed
 3. Nitella
 4. Wild celery (at right)
 5. Coontail
